Test Report

No. SDHL2003002353GA

Cover Valet
Long Beach, CA

Sample Description : PERGOLA 3X3.6M
Supplier Item No. : MI-3X3.6
Manufacturer : COVER VALET
Supplier : COVER VALET
Buyer :
Country of Origin : CHINA
Country of Destination : USA
Sample Receiving Date : Mar.16, 2020
Test Performing Date : Mar.17, 2020 to Mar.26, 2020

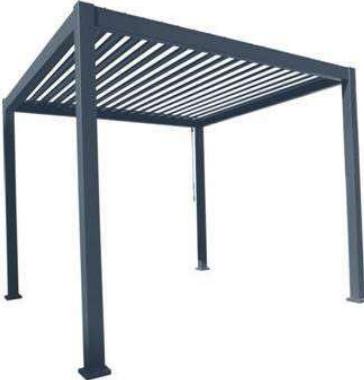
Sample view	Photo of test

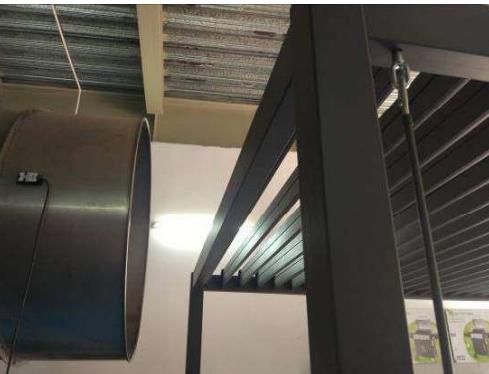
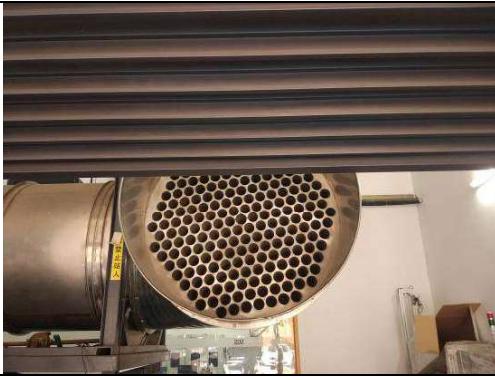
/
Photo of test	/

SGS In House Method		
Requirement	Remark	Verdict
Wind resistance test		
Install the pergola according to the manufacturer's instruction and make the center of side structure (top rail) to face the wind tunnel. Adjust the height of outlet of the wind tunnel if necessary. All the legs shall be secured to avoid moving during test. The pergola shall undergo total five times of wind resistance test, with using different ranks of wind speed (10m/s, 15m/s, 20m/s, 24m/s and 28m/s.) from low to high. The wind shall be applied to the center of the side structure (top rail) and shall keep a steady speed for 30 seconds in each rank of test. The pergola should be checked thoroughly after each time of test. The pergola shall have no damage or irreversible deformation after each rank of test. The test should be stopped when it becomes conscious of any damage or irreversible deformation.	See the Annex test table 1	Pass

Test wind speed	Wind scale	Verdict
10m/s	5	Pass
15 m/s	7	Pass
20 m/s	8	Pass
24 m/s	10	Pass
28 m/s	11	Pass
